# **Cottingham and Middleton Conservation Area Appraisal and Management Plan**

## **Supplementary Planning Document Revised Draft**

22<sup>nd</sup> February 2016

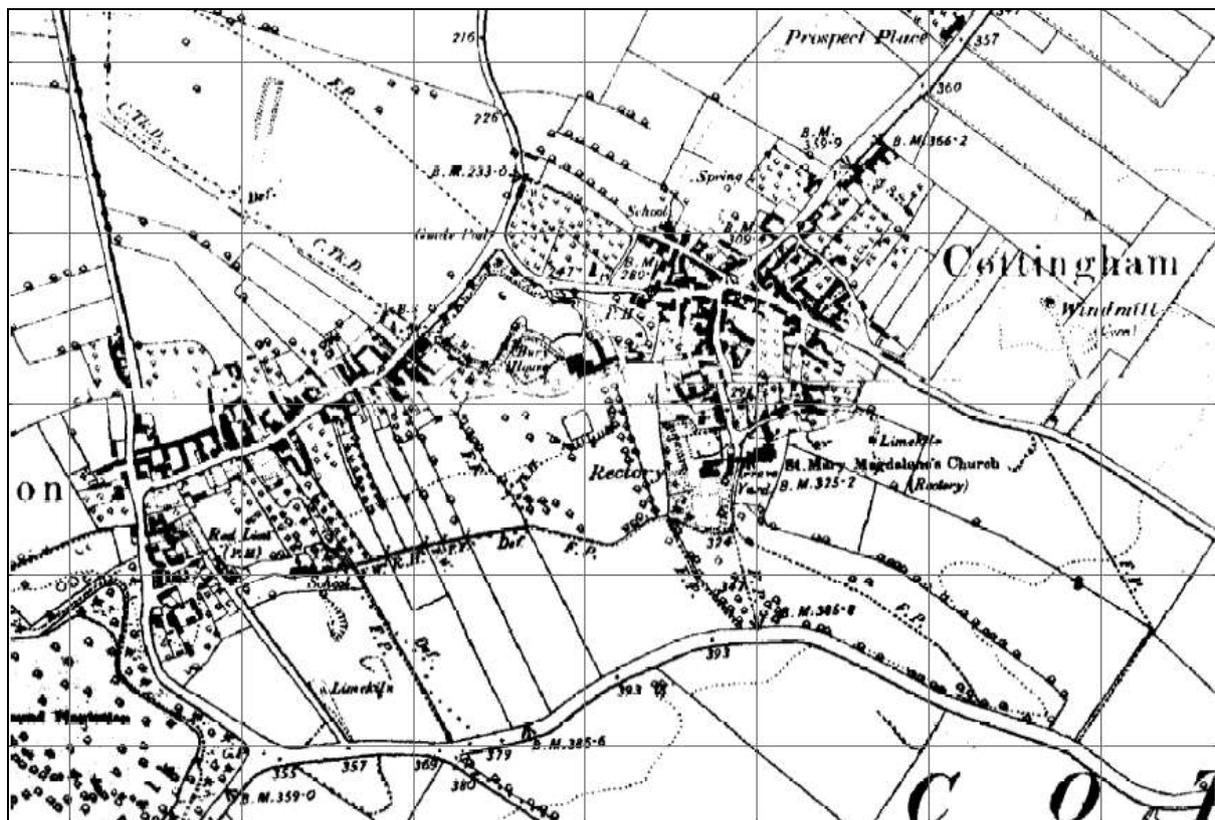
Figure 7 – 1885 Ordnance Survey Map

The mid to late 19<sup>th</sup> century was a period of great building activity in both villages. The Palmers built an attractive pair of Jacobean-style almshouses at the foot of The Hill and provided a water trough set into the boundary wall of their Deer Park. *Milestone House* (no. 25 Main Street) is an interesting small detached 3-bay symmetrical farmhouse with banded ashlar window lintels. No. 20 Main Street is similar and may have had a hipped roof originally prior to no. 18 being added on to its west side. No. 10 Church Street also has a similar banded limestone lintel-band above its ground-floor windows contrasting with the orange coloured ironstone walling. Most roofs are gabled and few hipped roofs are to be found in the villages; No. 5 School Hill (dated 1863) has a similar hipped roof to that of *Milestone House* but is entirely built of limestone. In the 1870s the Rectory was partly rebuilt (1876 to 78) and extended, and the church was restored from 1878 to 1880 with a mostly new Chancel. While the church was closed for rebuilding the Methodists also decided to rebuild their earlier chapel of 1808 in 1879, in brick with a Classical gable-ended entrance front facing on to The Nook. This in essence is similar to the design of the taller 3-storey brick clothing factory built on the Rockingham Road in 1874 for Wallis & Linnell, which undoubtedly led to an increase in the working-class population of the village almost certainly leading to the construction of the new Methodist chapel at a time when the parish church was closed and being re-built. This would accord with earlier practice when the Congregationalist opened a chapel on Main Street, Middleton in 1808, leading the Methodists to build a rival nonconformist chapel the same year.

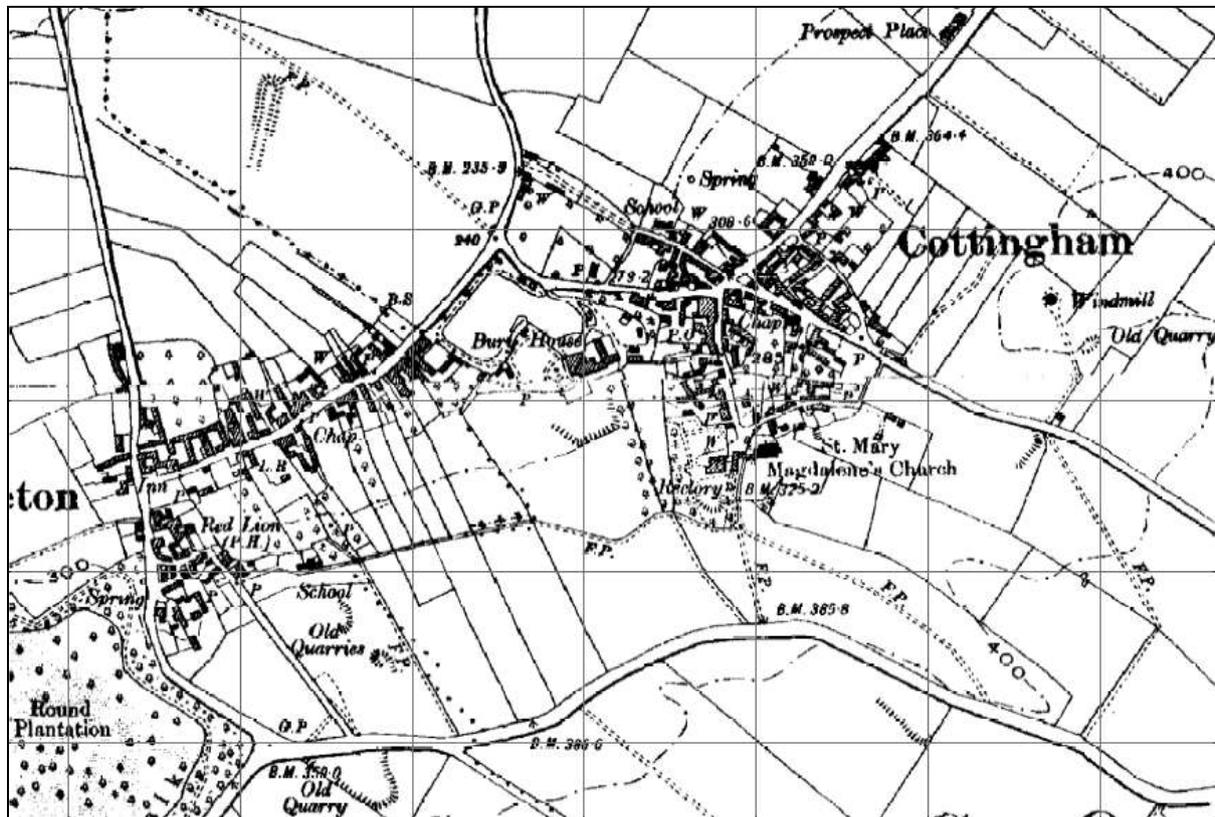
Figure 8 – 1900 Ordnance Survey Map

The 20<sup>th</sup> century brought further development to the villages with small sites having infill development and the site at Bury Close on land owned by Cottingham Hall developed with a dispersed group of houses. This development acts as a fulcrum physically connecting the two villages.

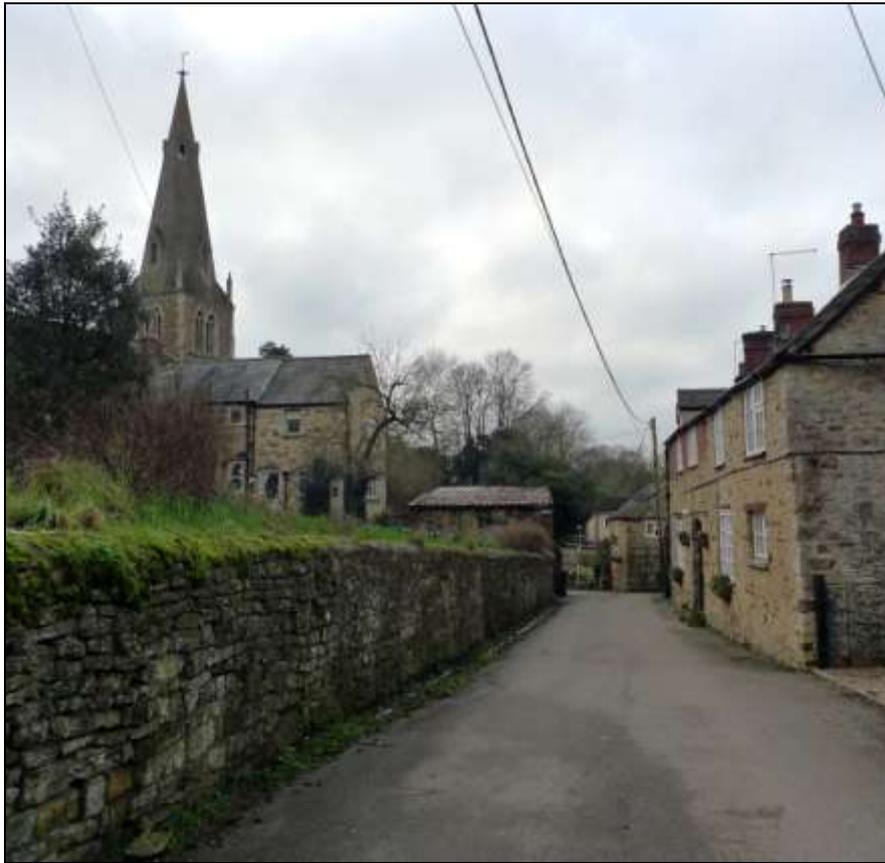
**Landmarks** – landmarks are structures that because of either size or design stand out

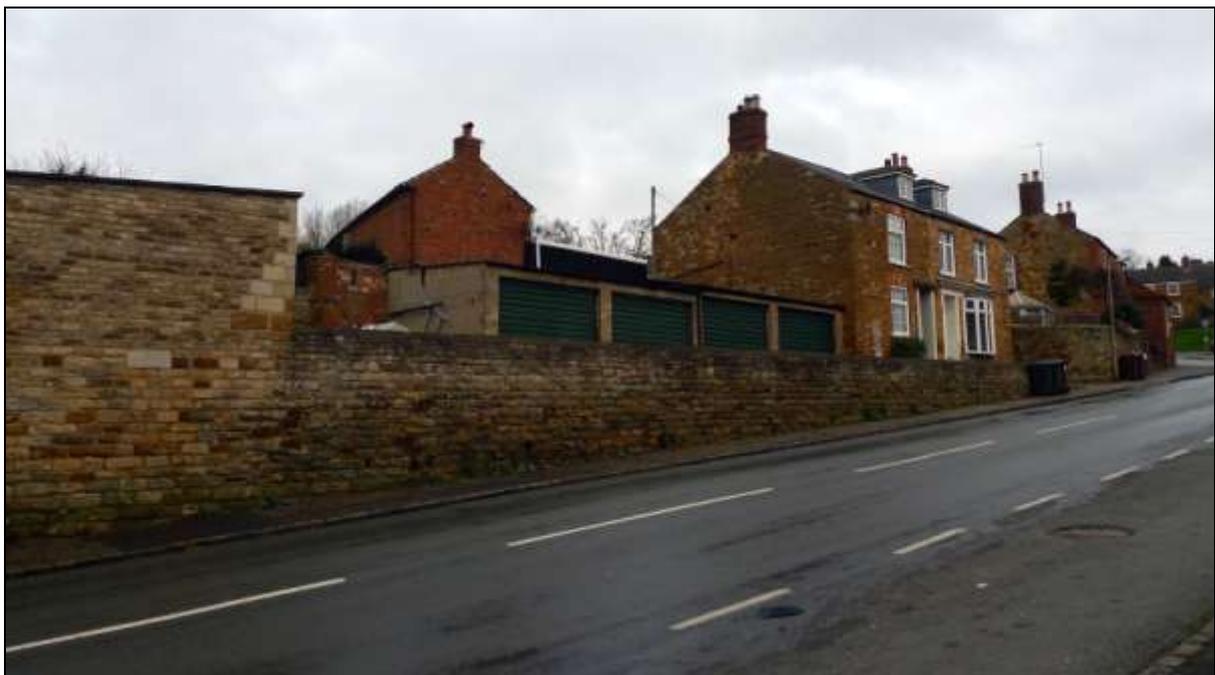
**Negative buildings** – these buildings in scale, materials, design or massing, or a combination of these, have a negative effect on the character of the conservation area. They do not relate to the surrounding topography or building form and are usually sited on a prominent site.

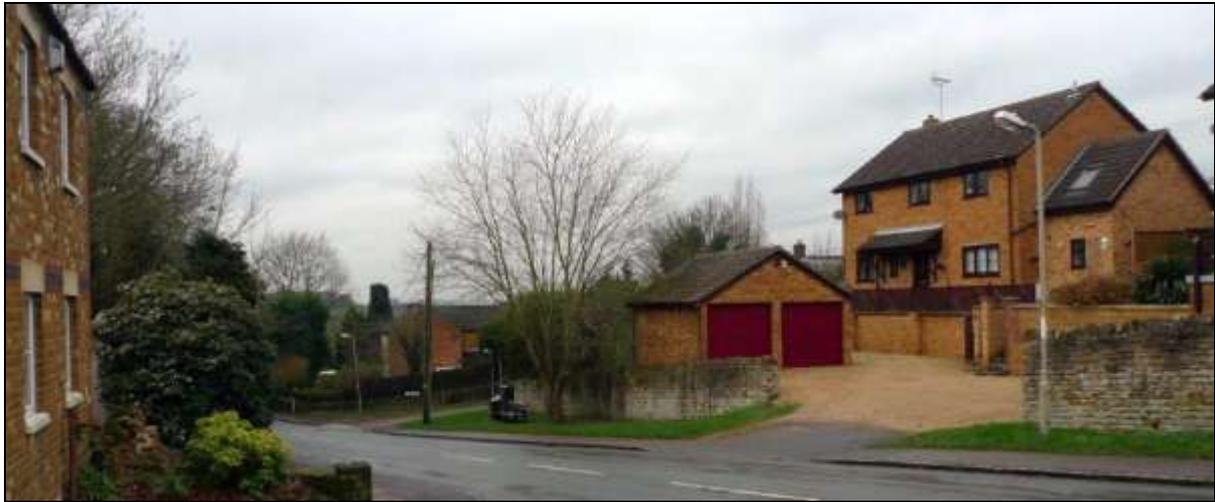
**Neutral Buildings** – these buildings are often 20<sup>th</sup> century buildings that are unobtrusive, and usually respect the topography, scale, materials and detail of the surrounding built form. Neutral buildings are also occasionally older properties that have been heavily altered and, for this reason, no longer preserve the character of the conservation area.

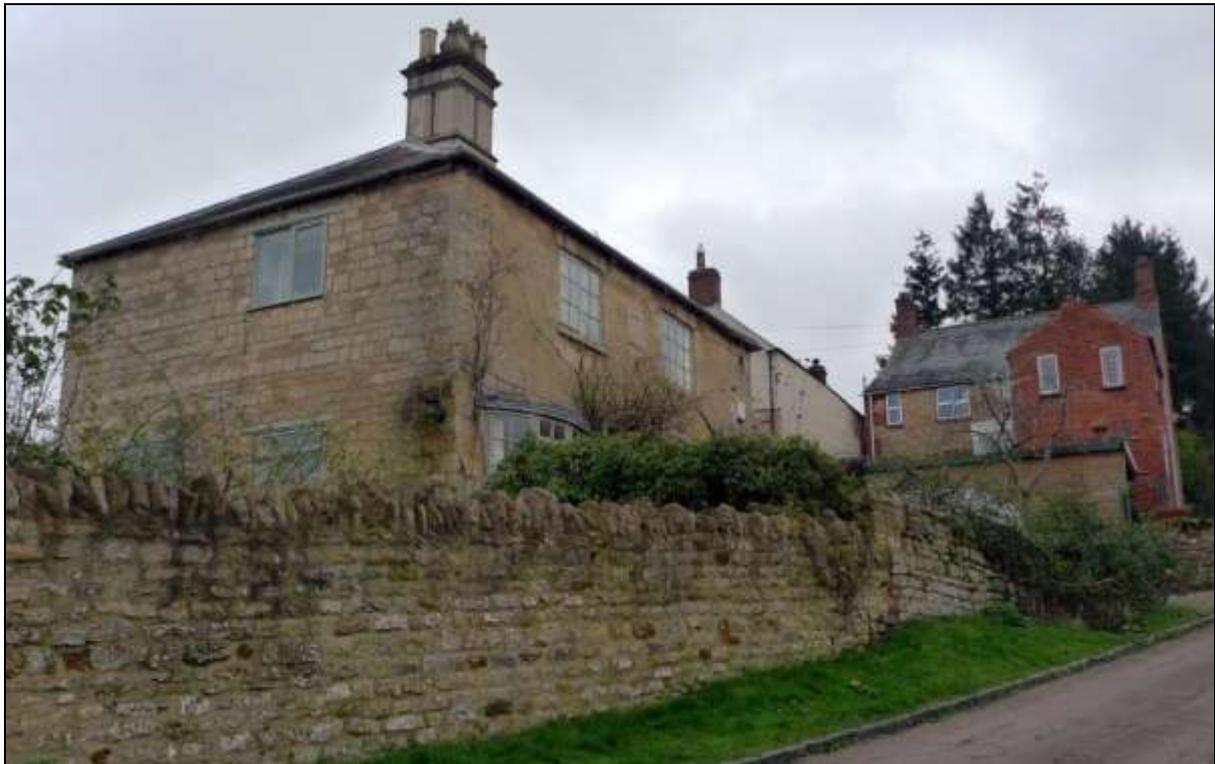
**Positive Buildings** – positive buildings are those that are of special architectural or historic interest, either as individual structures or as part of a collective group, and make a strong contribution to the character of the conservation area.

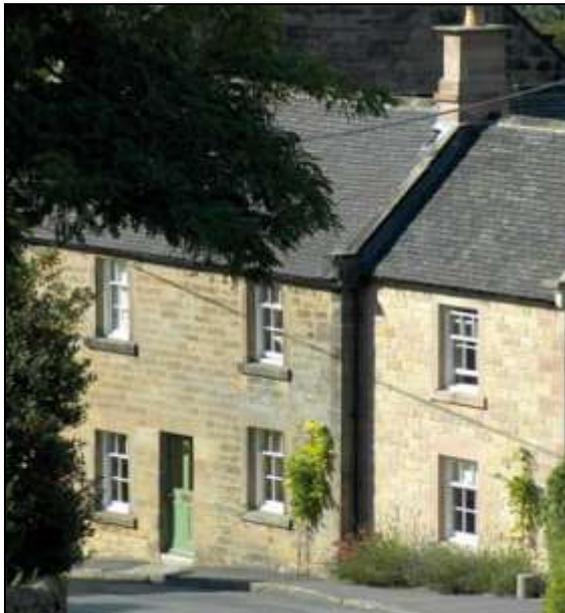
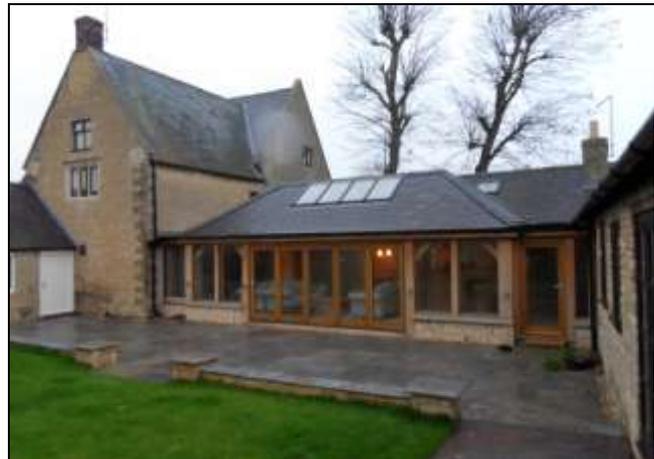
There are many local examples in the villages around Corby and throughout the Northamptonshire area. Some properties feature side extensions with additional lower roofed lean-to extensions built on to them providing an organic development character that is considered a suitable model. A design that keeps the integrity of the original design of the house and its façade and clearly creates a new extension that is subservient to the original but compliments the original design and is subtly linked to it is desired.

Rear extensions should not dominate the original building, should adopt the same or similar materials to the original building for both the walls and the roof. The fenestration and doors should reflect the style and form of the original building or complement in a contemporary way the openings and style of the original building.

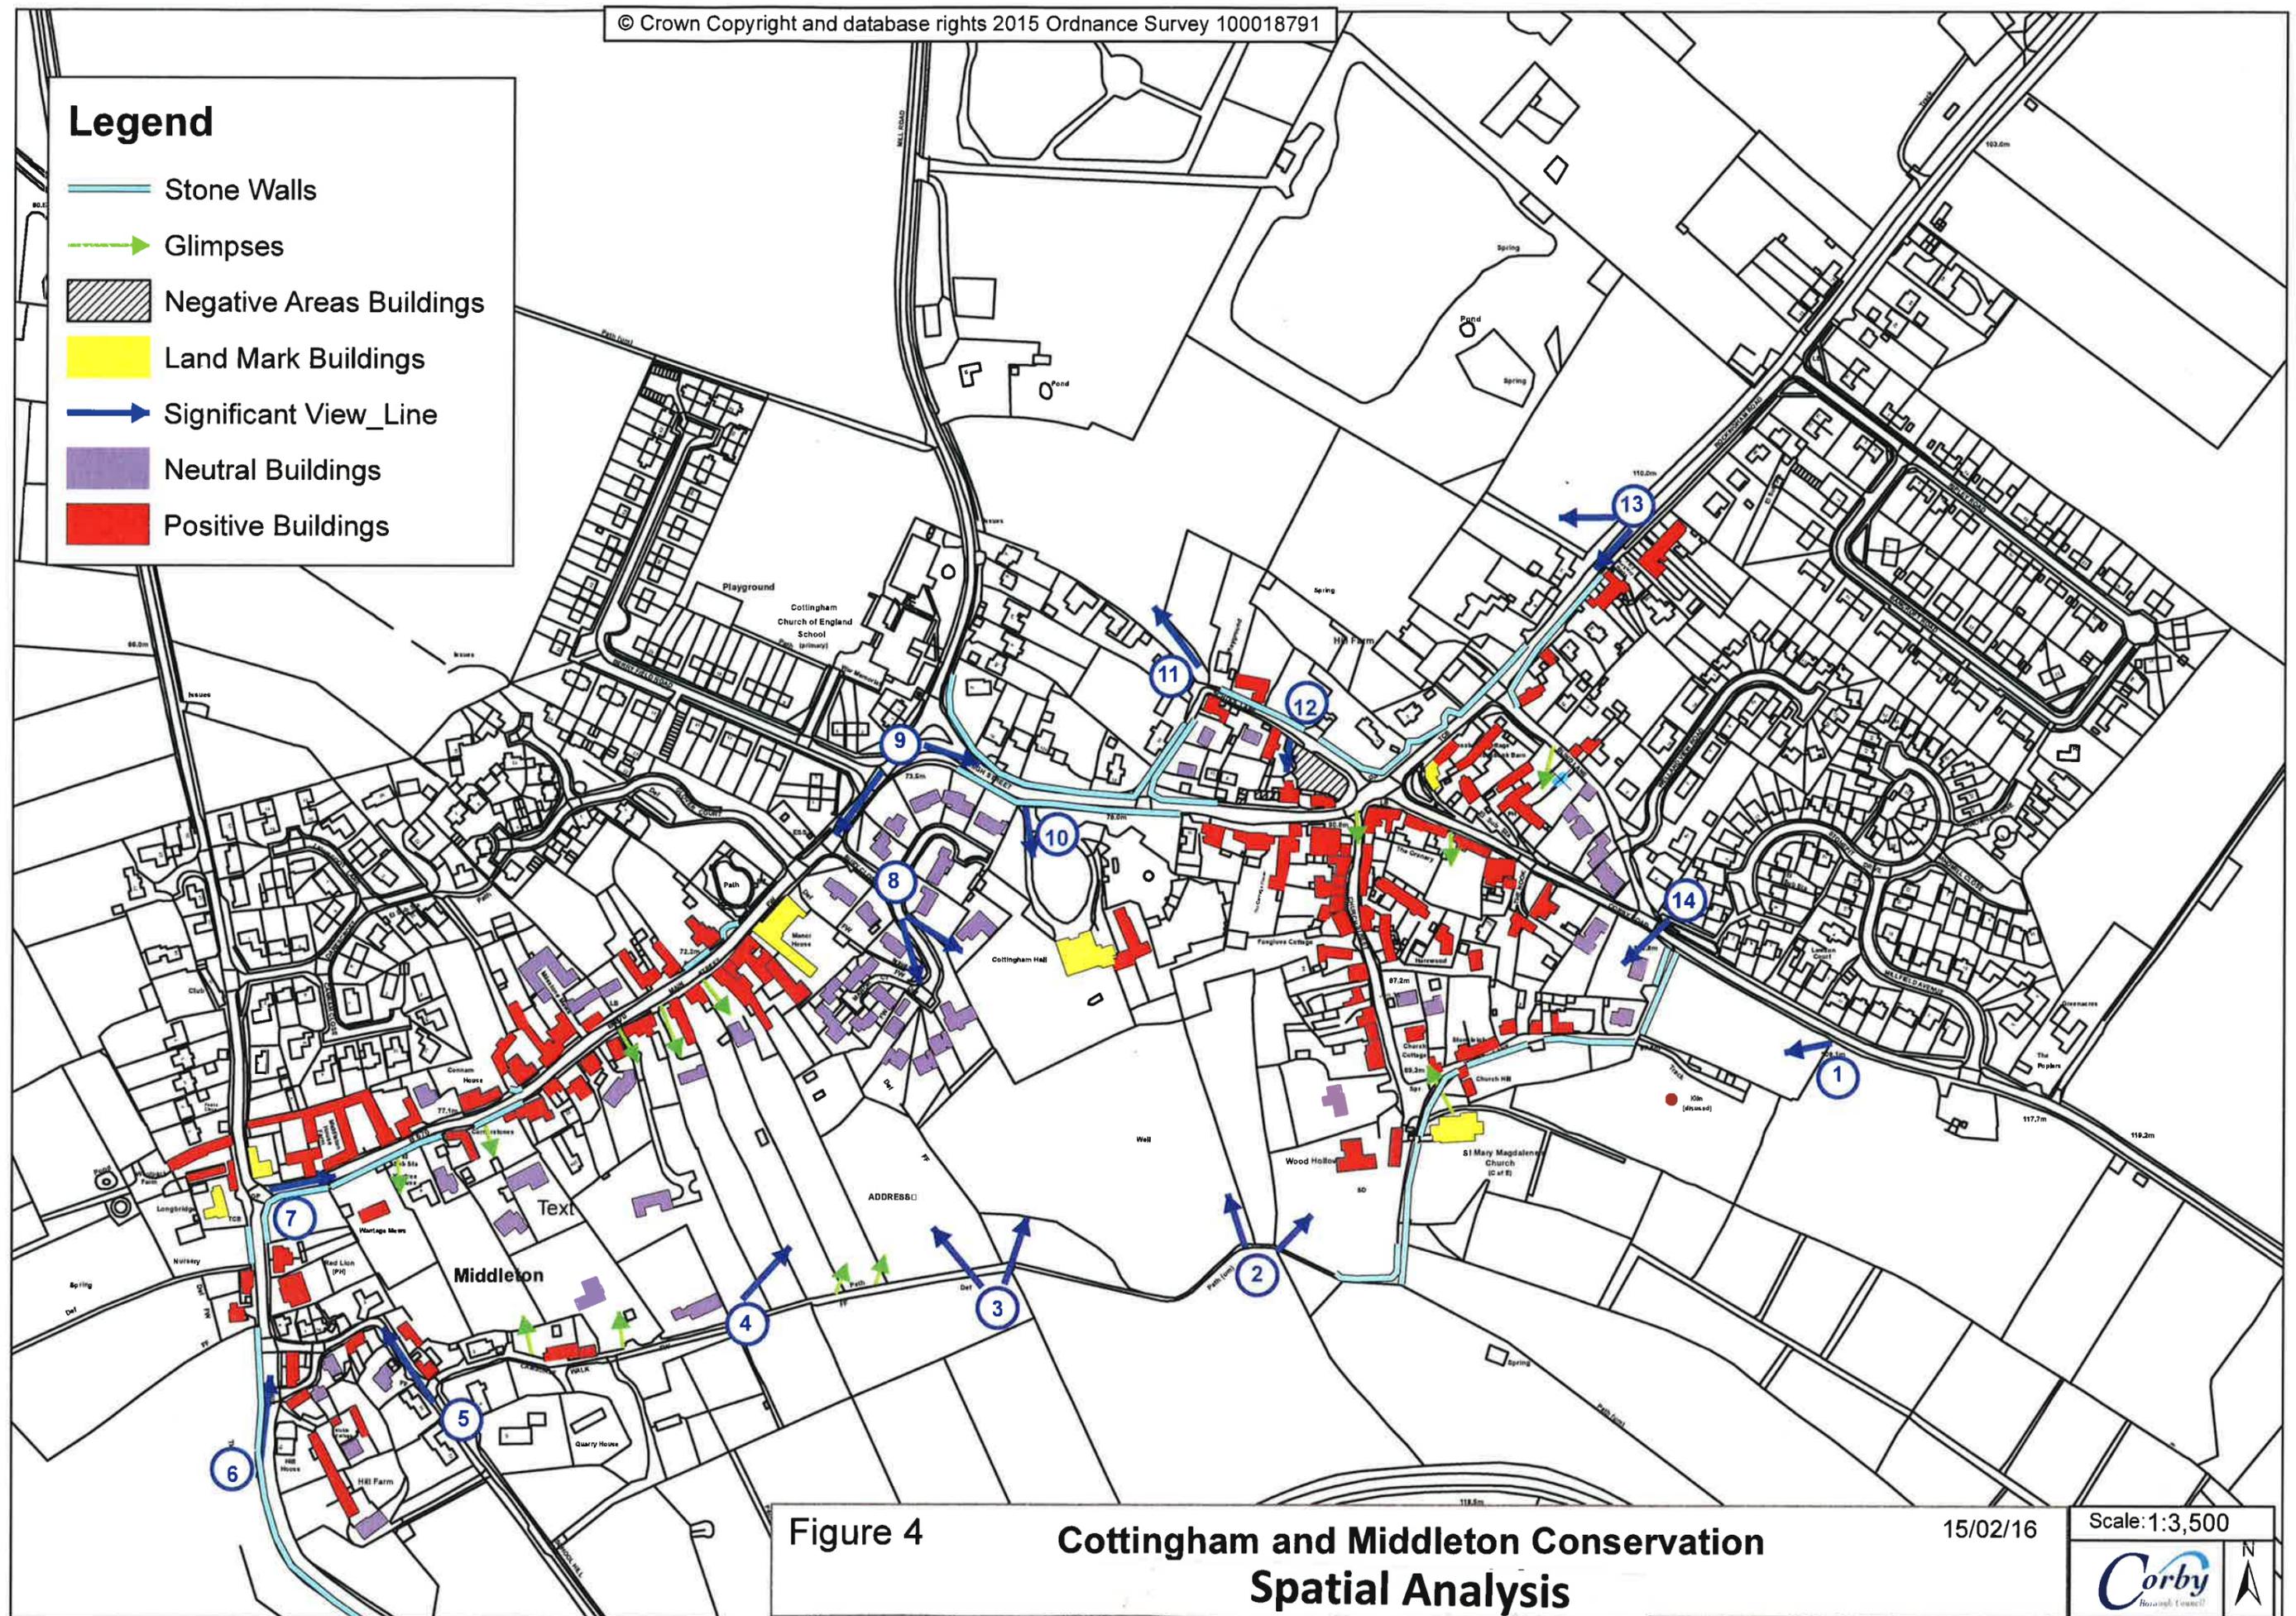
Figure 4 captures the spatial analysis of the conservation area including the significant views; open spaces; landmark buildings; positive buildings; neutral buildings; important walls; glimpsed views and negative areas.

## Cottingham and Middleton Conservation Spatial Analysis

The Spatial Appraisal Figure 4 highlighted a number of negative sites where a scheme of improvement would be to the benefit of the area. These improvements might take the form of a more sensitive handling of a roof profile or replacement or reinstatement of stone wall. These changes could be included in a future enhancement action plan.

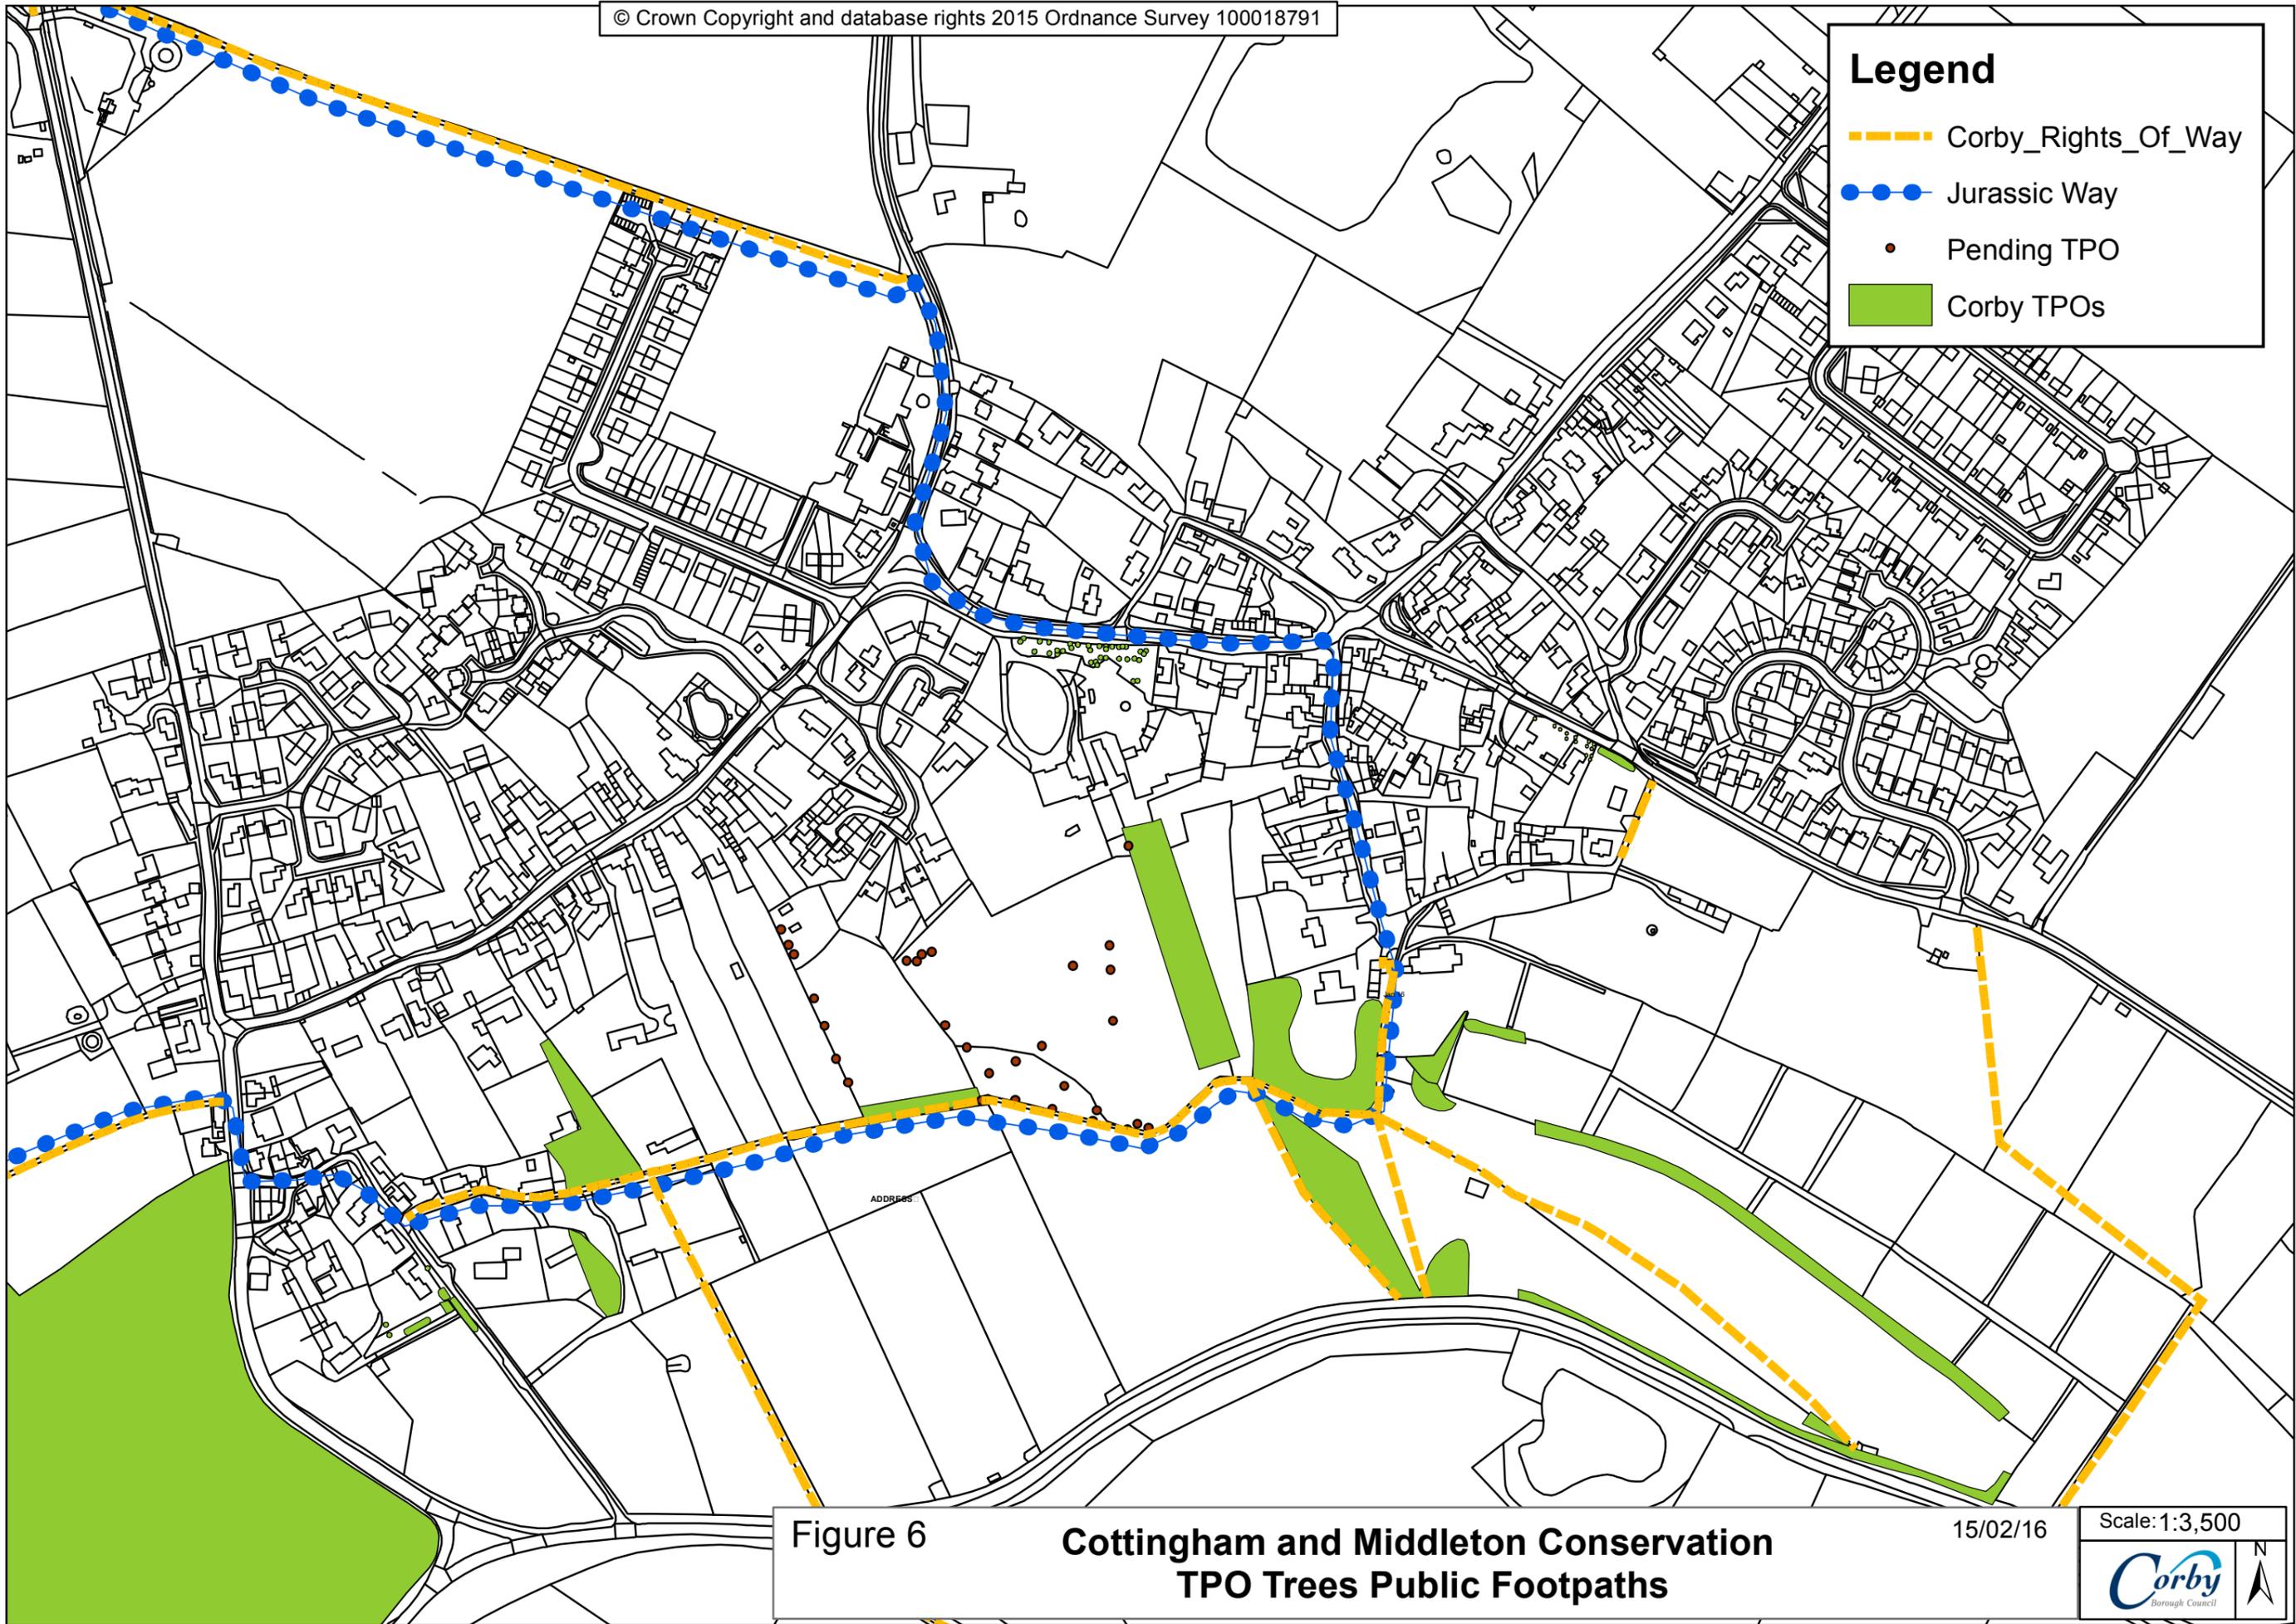
Figure 6 Cottingham and Middleton Conservation TPO Trees Public Footpaths

There are several groups of trees within the conservation area that have a Tree Preservation Order. These are illustrated in Figure 6.
